RELIABILITY IMPROVEMENT OF COOLING WATER PUMP

P. YOGESH¹, R. RAGHAVAN², R.VIGNESHKUMAR³,
R. HARISH⁴ & K. PRAVEENKUMAR⁵

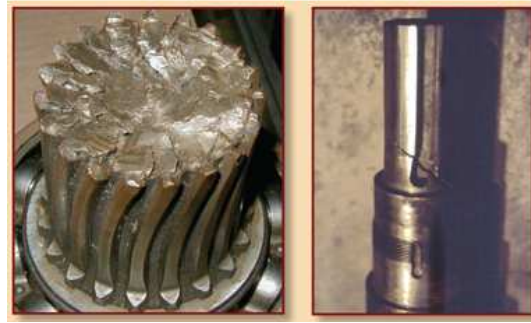
No pole materials are completely fragile or totally flexible. The poles utilized on all engines, reducers and fans are low-or medium-carbon steels and generally flexible. Thus, when an extraordinary over-burden is set on these materials, they bend and twist. The twisted shaft appeared in Photo 1 has been terribly over-burden by a torsional push.

Figure 5: This Shaft has been Grossly Overloaded by a

Figure 6: Occasionally, a Ductile Shaft will fail in a somewhat

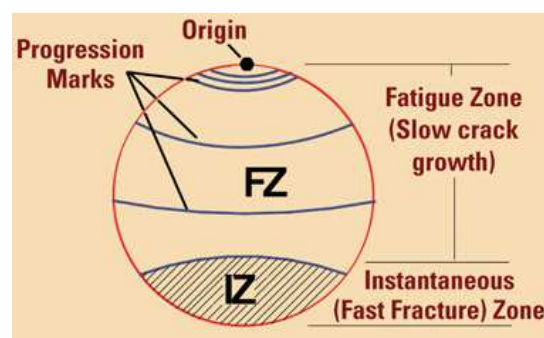
Figure 8: This Typical Plane Bending Fatigue Failure Shows How a Crack Starts at the Origin and Grows across the Fatigue Zone, When the Crack Reaches the Boundary of the Instantaneous Zone, its Growth Rate Increase Significantly

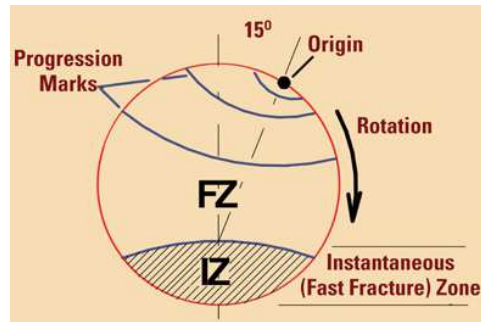
Figures 9 and 10, be that as it may, indicate cases of pivoting twisting. The contrast between these two disappointments is that the pole in Figure 4 has a solitary birthplace, while the crack in Figure 5 has various causes. Taking a gander at the two portrayals, we see the IZ of Figure 4 is the bigger of the two—which demonstrates that the heap on the pole when it fizzled was more prominent than that on Figure 5. The investigation, likewise demonstrates that, despite the fact that Figure 5 was less intensely stacked, it had numerous more crack starting points, a sign of a high-pressure focus, for example, a pole advance with a little span. The ratchet marks are the planes between contiguous break roots and develop opposite to the split engendering.

Figure 9: In this Example of Rotating Bending Failure, the Fracture has a Single Origin (and the Load on the Shaft when it Failed was Greater than that on Shaft in Figure10 when it Failed)

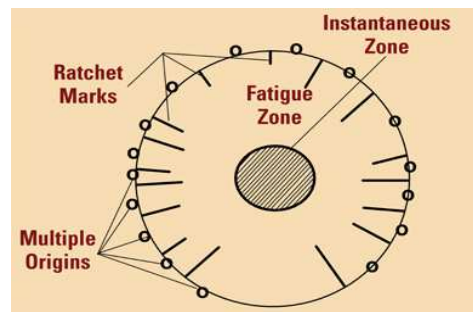
Figure 10: Analysis of this Rotating-Bending Failure (with its Multiple Fracture Origins) Showed that the Shaft was Less Heavily Loaded than that in Figure 9 when it Failed

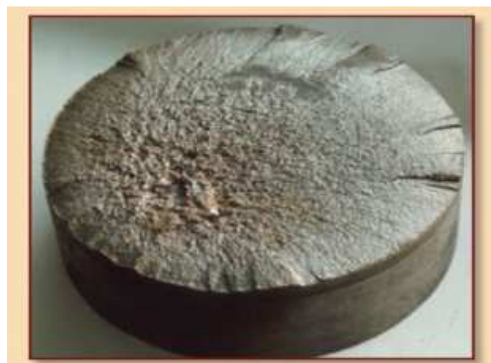
Figure 11: The Shaft on this 200hp, 1180 RPM Motor Failed in Less than a Day as a Result of Badly Worn Sheaves on the Belt Drive

A few cases of plane and pivoting twisting weakness determination is appeared in Photos 11 and 12. Photo 11 demonstrates a 200 hp, 1180 RPM engine shaft that bombed in under a day. No movement marks implies the weakness stack was steady. The momentary zone is generally huge, demonstrating the pole was intensely stacked. Splitting began at various areas around the pole, indicating pivoting twisting as the reason. Such huge numbers of ratchet marks focused on the best and base of the photograph make us speculate the pole might not have been straight. Assessment, however, would demonstrate the main driver was related with the belt drive. Truth be told, the piles were worn so severely that the belts were riding in the base of the depressions. This circumstance around, multiplied the pole twisting stress. The drive shaft in Photo 12 was on a steel-process lift. The surface is smoothest close to the base of the keyway and turned out to be dynamically rougher as the break developed over the pole. Various movement marks encompassing the modest IZ and the adjustment in surface condition around 40% of the path over the pole from the IZ recommend something changed amid the split development or that the lift was not utilized for an expanded period. These highlights are demonstrative of a moderate developing disappointment—and the way that fussing erosion may have generously diminished the exhaustion quality.

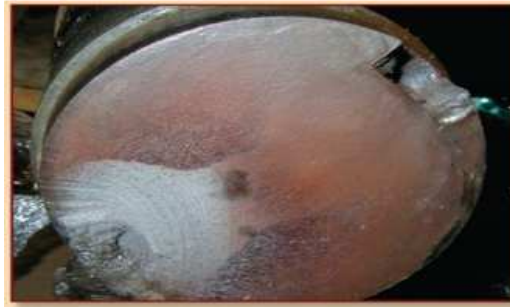
Figure 12: This Slow-Growing Failure on a Steel-Mill Elevator Drive was Initiated by Fretting Corrosion that Substantially Reduced the Failure Strength on the Shaft

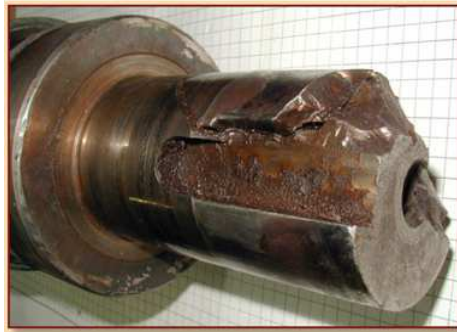
**Figure 13: The Terrible (Loose) Coupling Fit on tis Motor Shaft
Allowed the Hub to Repeatedly Dive the Key against the
Side of the Keyway until a Fatigue Developed**

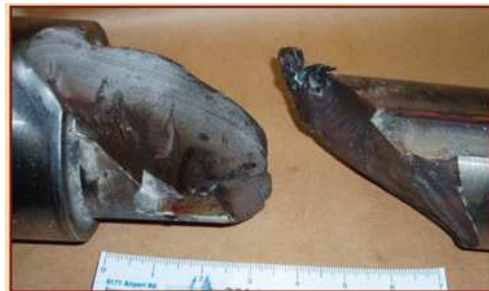
Photograph 14 indicates the two parts of the torsional-exhaustion disappointment of a fan shaft in a plant that had as of late changed to a VSD. The 45° edge to the focal pivot is a certain indication of torsional stresses, and the adjustment in surface unpleasantness over the pole demonstrates the reason was weakness powers.

**Figure 14: The Torsional Fatigue Failure of this Fan Shaft Occurred
Shortly after the Installation of a Variable Speed drive**

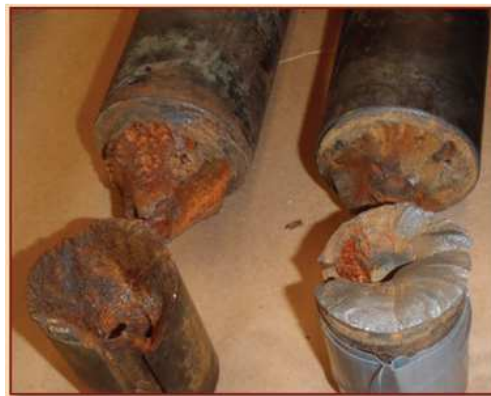
**Figure 15: These Pump Shafts Failed due to Torsional Fatigue
Aggravated by the Reduction in Strength caused by
Corrosion, not because of Rotating Bending**
